**UNIVERSITY OF PITTSBURGH
MEDICAL CENTER– CHILDREN'S
HOSPITAL**

**Pittsburgh Chemical Solutions LLC
5415 Coral Street
Pittsburgh, PA 15206**

THERMOPHASE has been utilized at UPMC Children's Hospital chillers since Q1 2021. This March will mark the third usage.

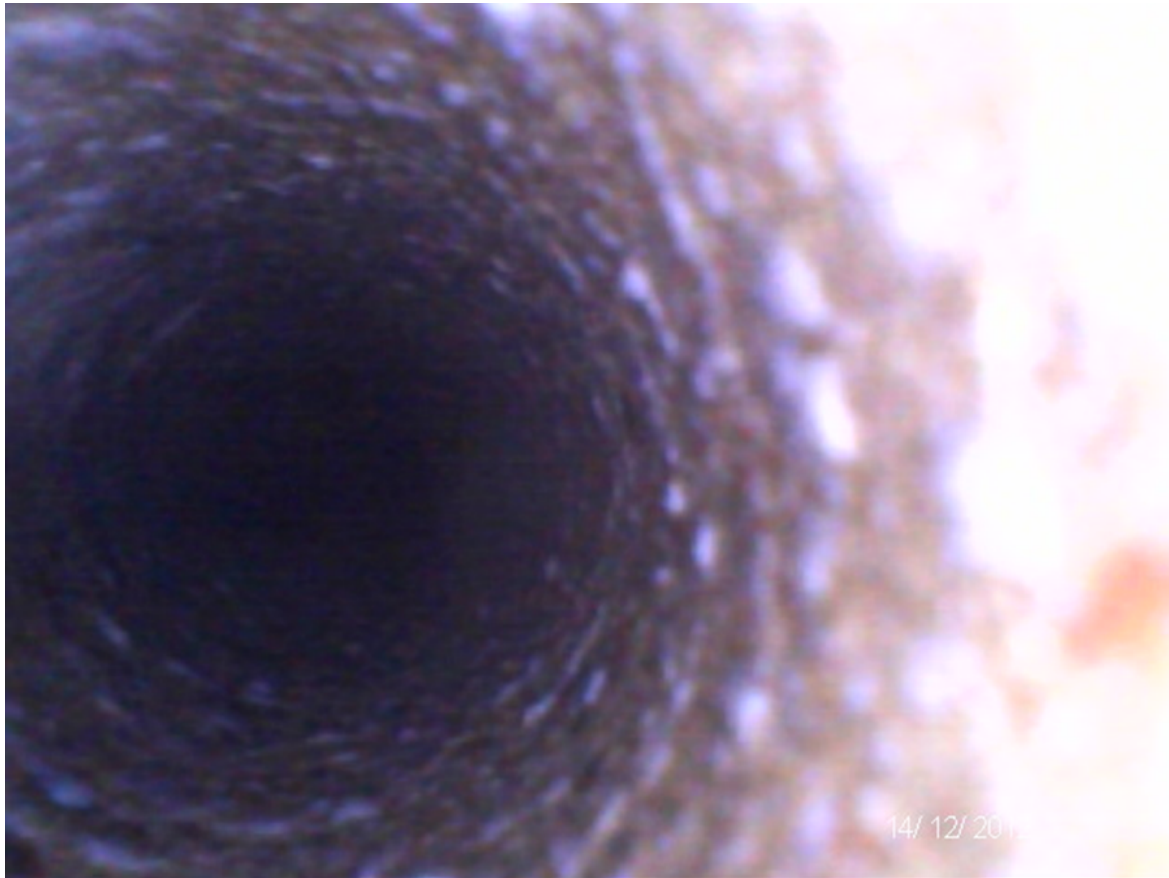
Prior to doing the first application in February/March of 2021, the chiller tubes were borescoped. As can be seen in Image 1 below, fouling is clearly seen on the walls of the tubes. UPMC cleans the tubes each year, so this is essentially a year of build-up.

Image 1: Borescope Image of Fouled Chiller Tubes from UPMC Children's Hospital Chiller in 2021

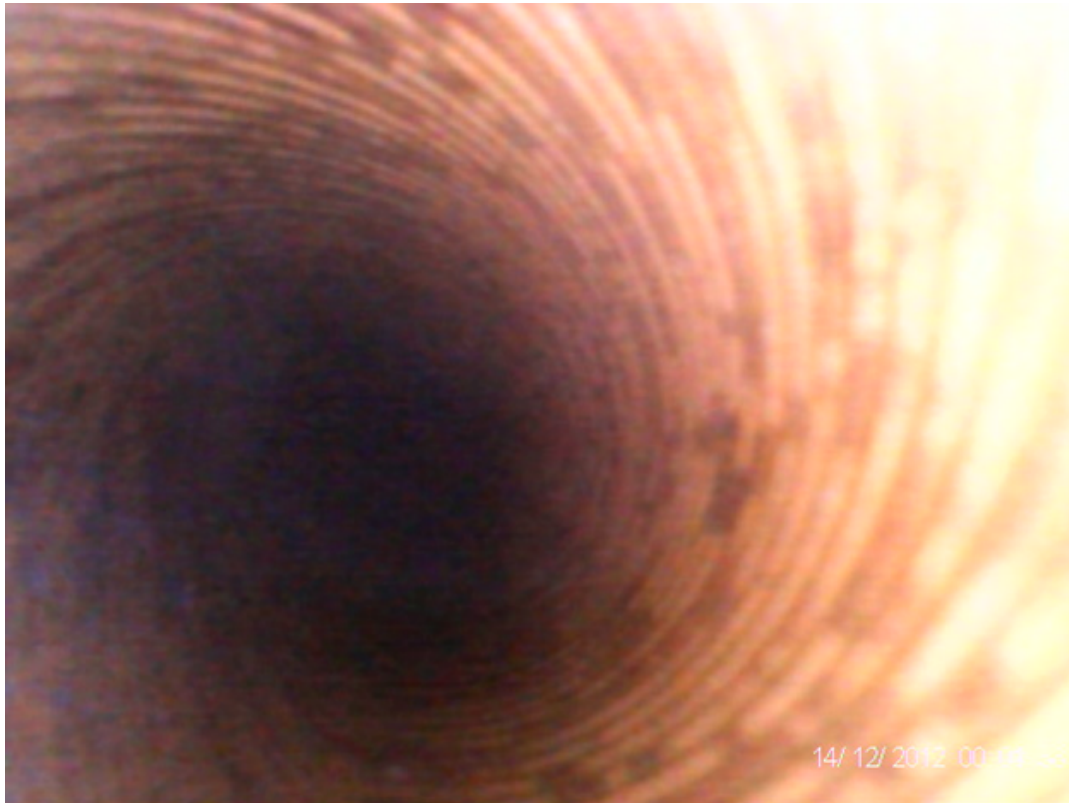
After the tubes were cleaned, the tubes were borescoped again. Image 2 below shows that the cleaning is sufficient to remove the fouling from the tube walls.

Image 2: Borescope Image of Chiller Tube After Cleaning from UPMC Children's Hospital Chiller in 2021

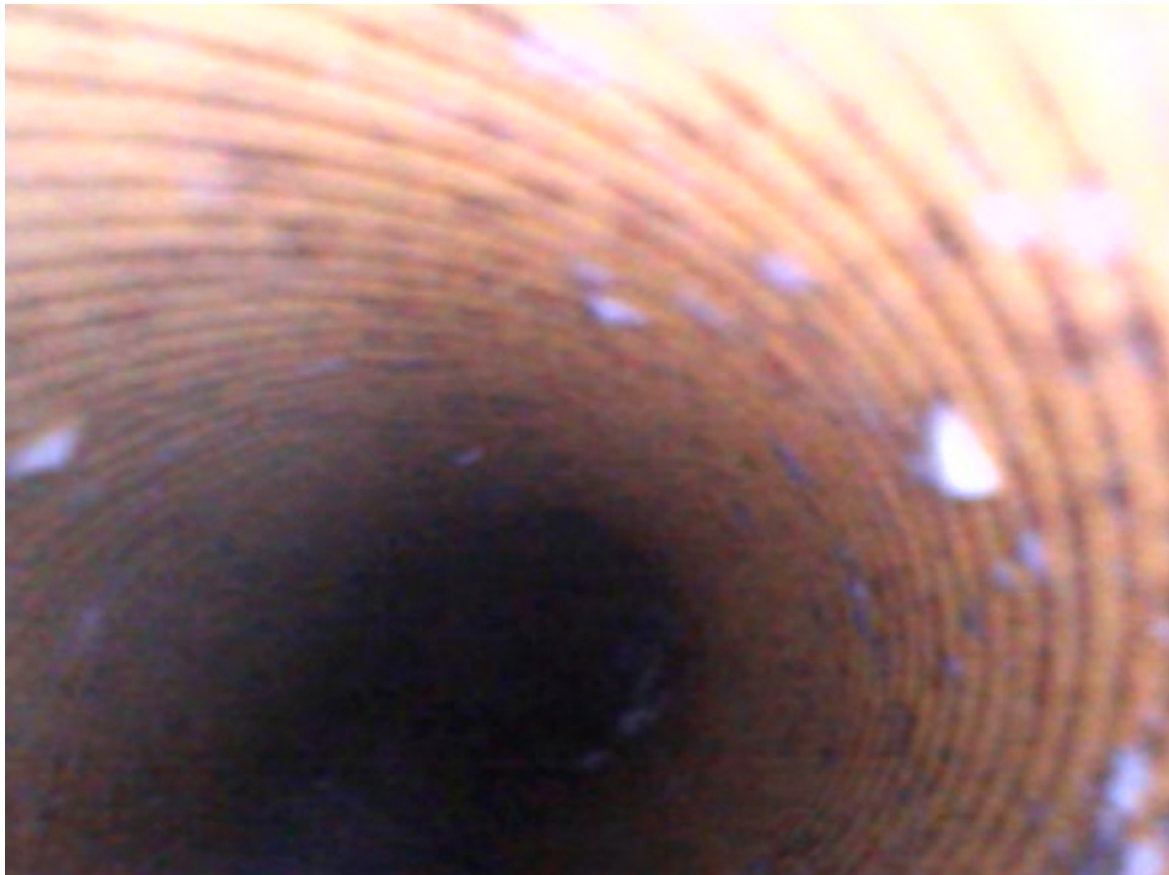
After the tubes were cleaned, THERMOPHASE was applied by circulating it through the offline chiller. The chillers were treated between February and March of 2021. Without any cleaning, the chiller tubes were borescoped the following year in January/February 2022. As can be seen in Image 3 below, there is very little noticeable fouling.

Image 3: Borescope Image of Chiller Tube 1 Year after THERMOPHASE application Without Cleaning in 2022

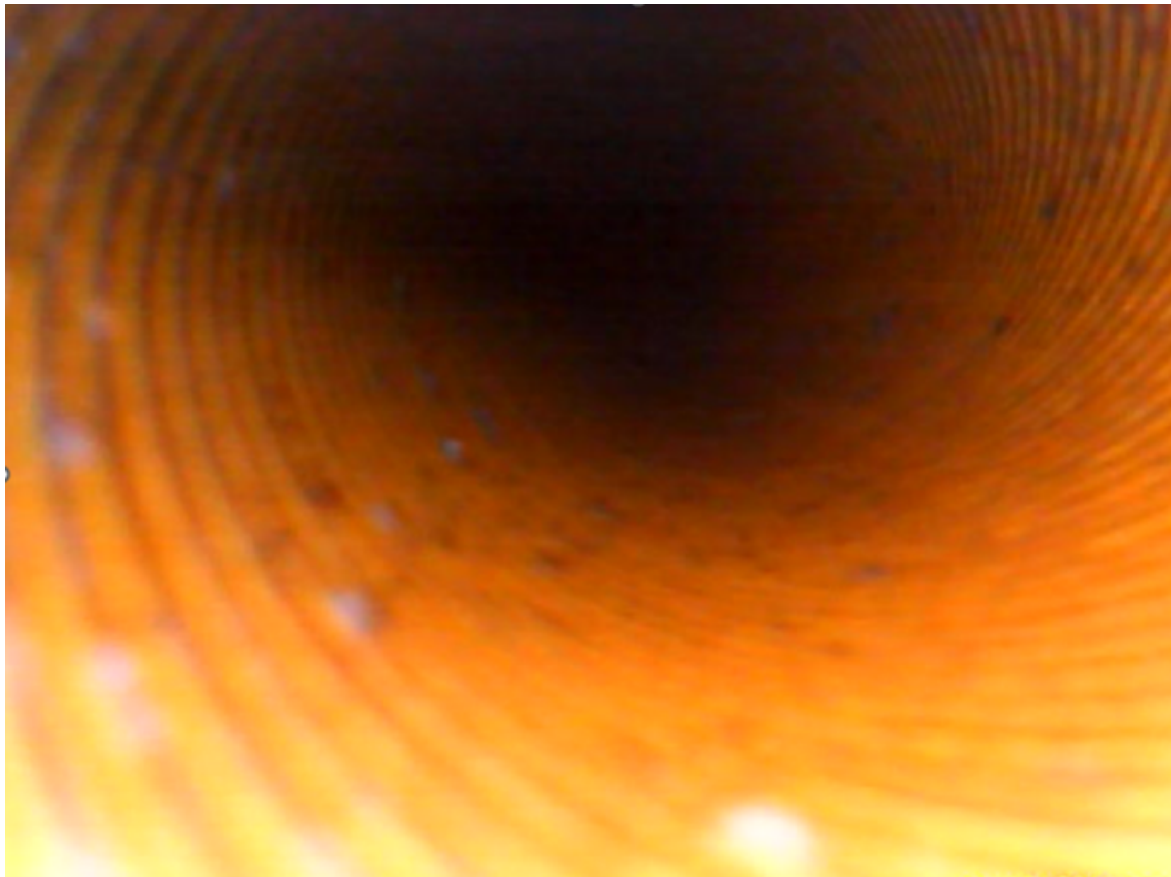
As a normal maintenance action, the tubes were again cleaned in 2022. THERMOPHASE was re-applied. The tubes were imaged again and shown in Image 4 below. Based on the borescope results the cleanliness of the tubes is excellent and no noticeable fouling. UPMC is considering forgoing cleaning this year.

Image 4: Borescope Image of Chiller Tube 1 Year after THERMOPHASE application Without Cleaning in 2023
